Use of Warm Magnetic Measurements in Locating Electrical Shorts in Magnets

Animesh Jain, John Escallier and Peter Wanderer

Superconducting Magnet Division
Brookhaven National Laboratory
Upton, New York 11973-5000, USA

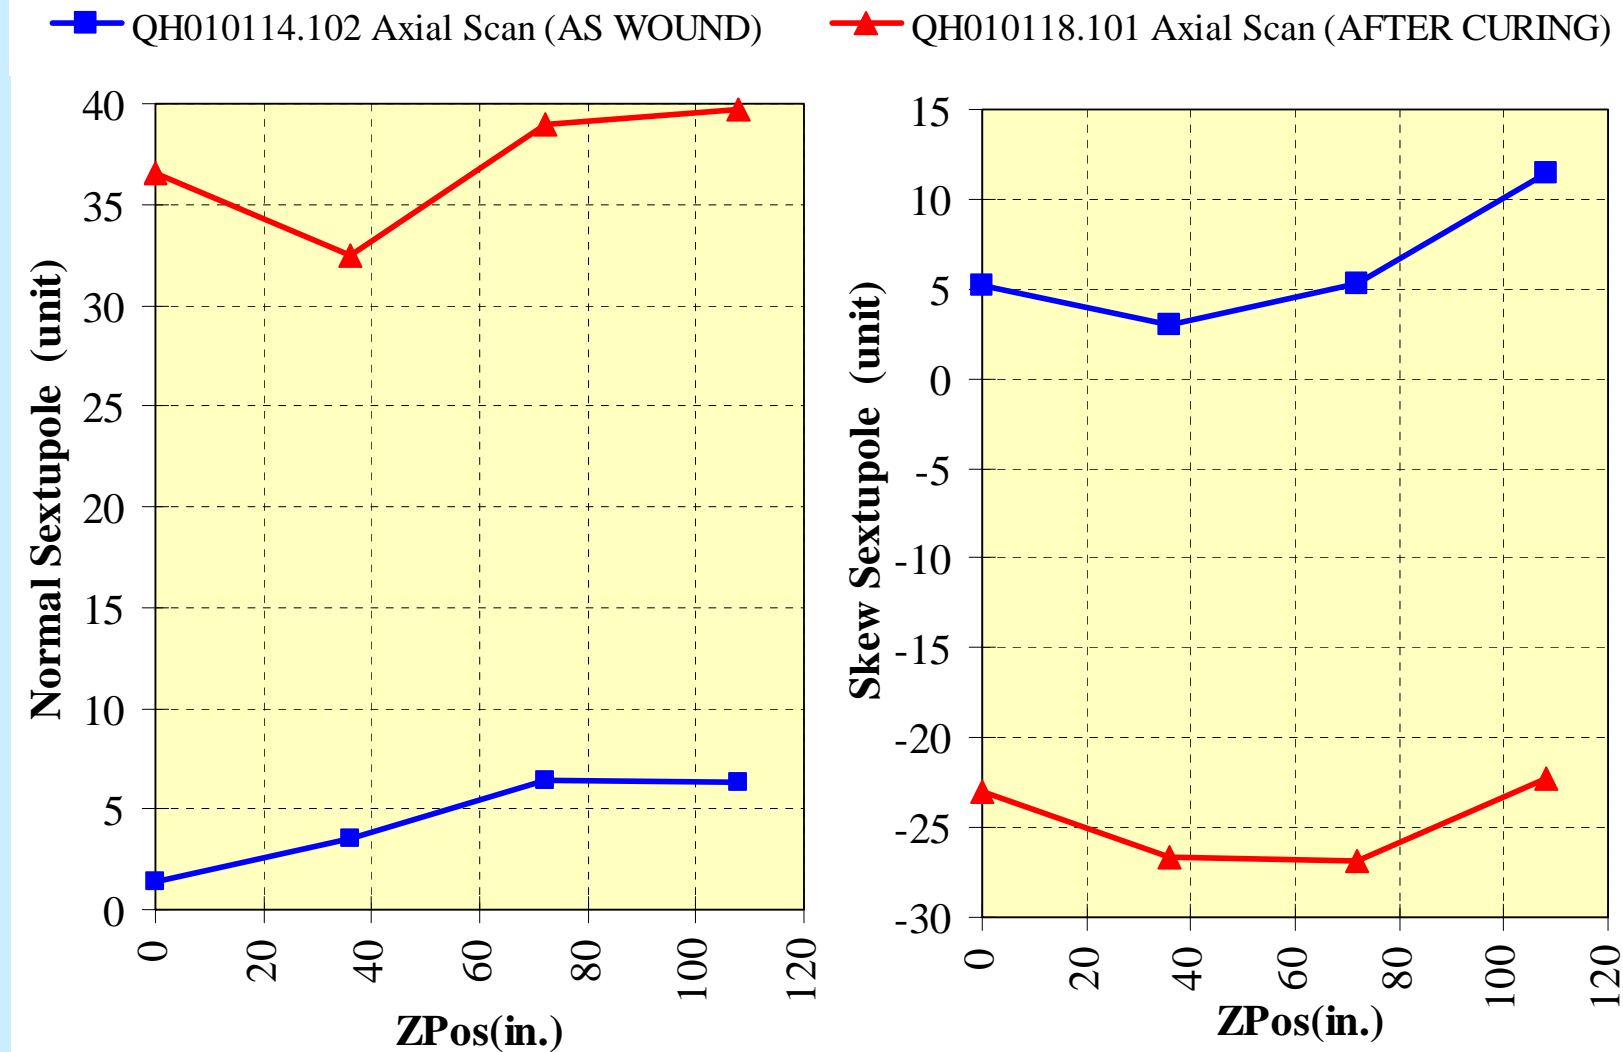
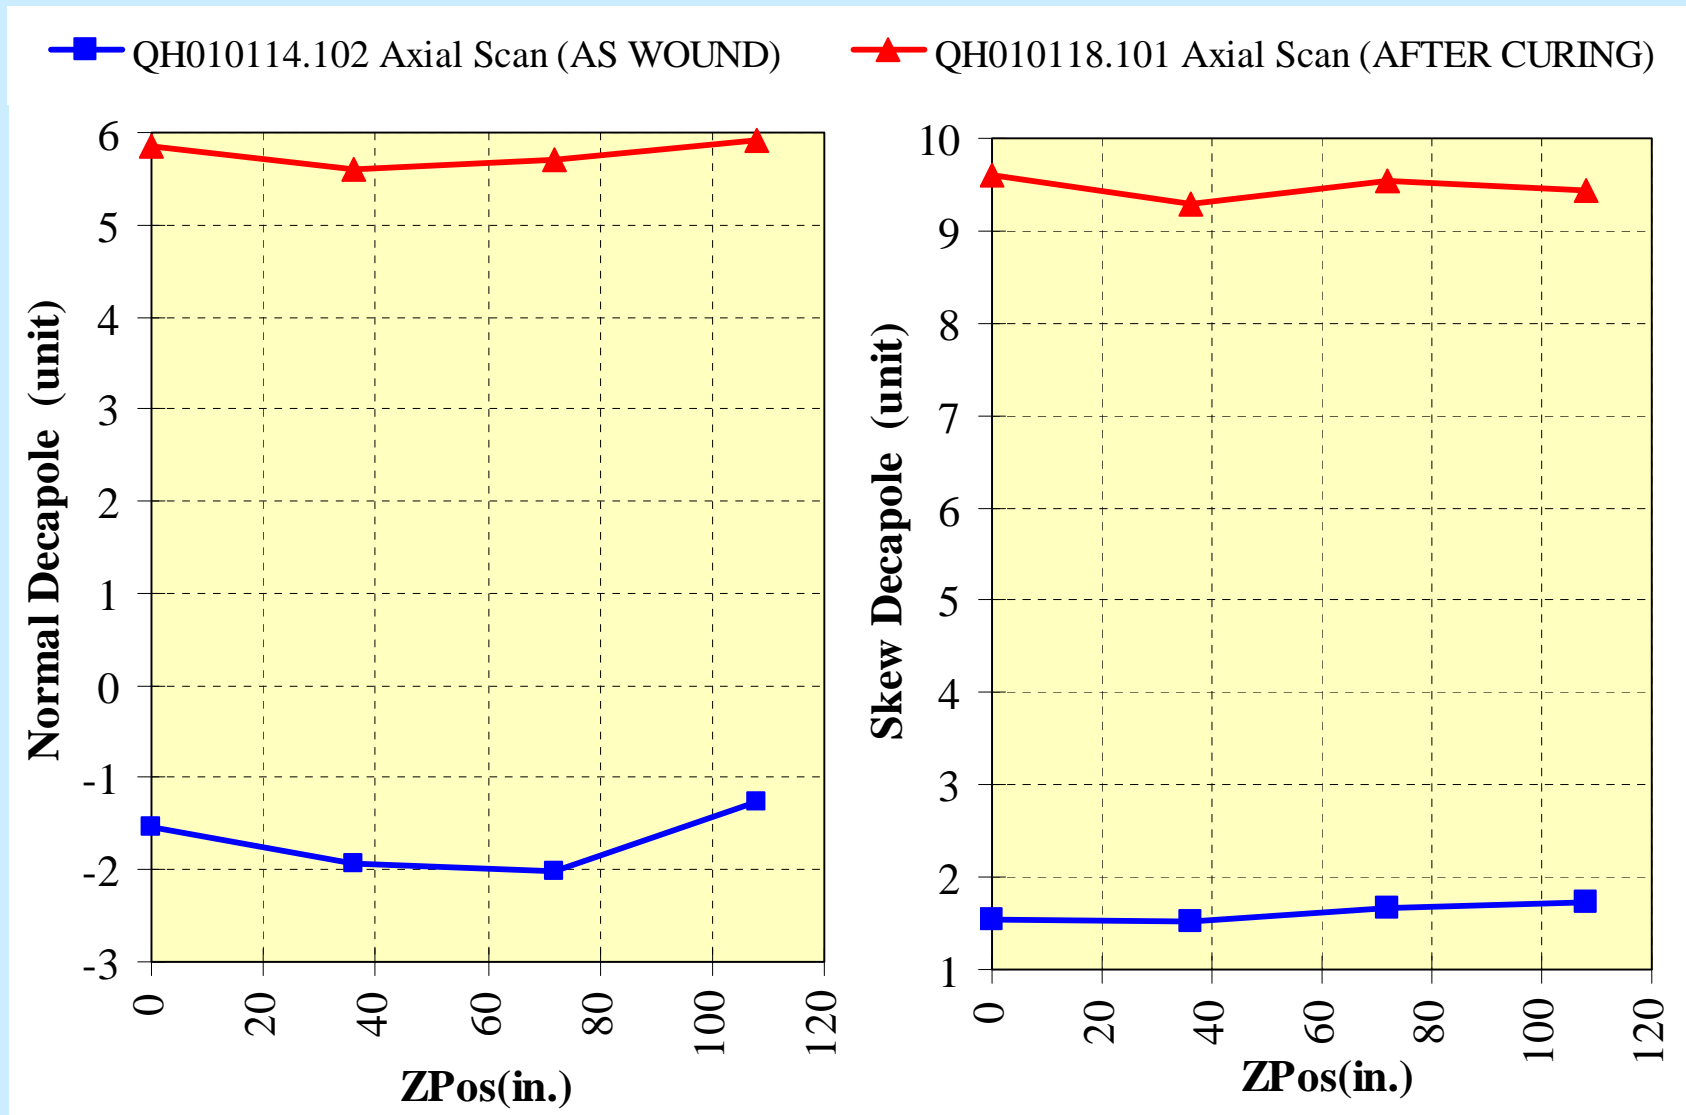
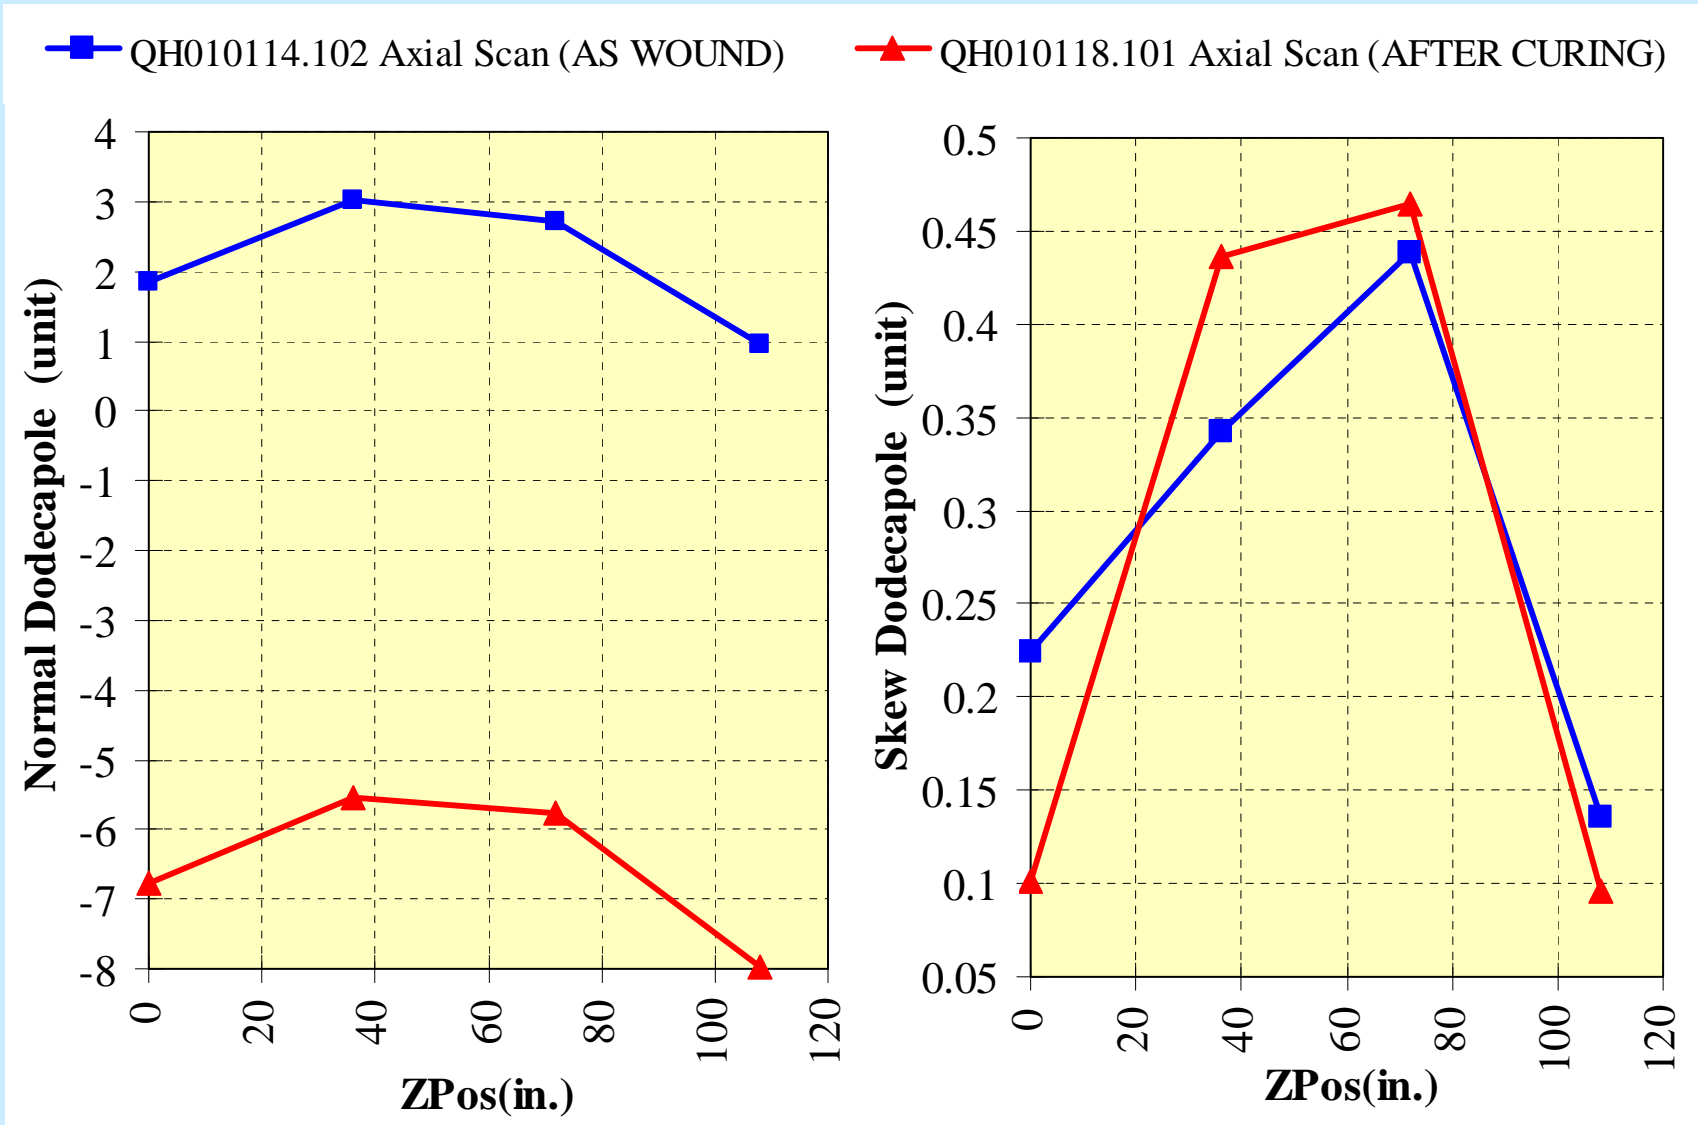
Axial Scans in QH0101: Q2 Layer

- Harmonic changes were too large.
- Transfer function was reduced, instead of showing an increase that was expected after curing.
- An axial scan showed essentially the same errors along the entire length, implying a problem at the ends.
- Positive normal sextupole and negative skew sextupole implied weaker field in the lower left region (the 3rd quadrant).
- Other harmonics could be used to pinpoint the location of the problem. However, the most likely place for an electrical short at the ends was at the midplane splice.

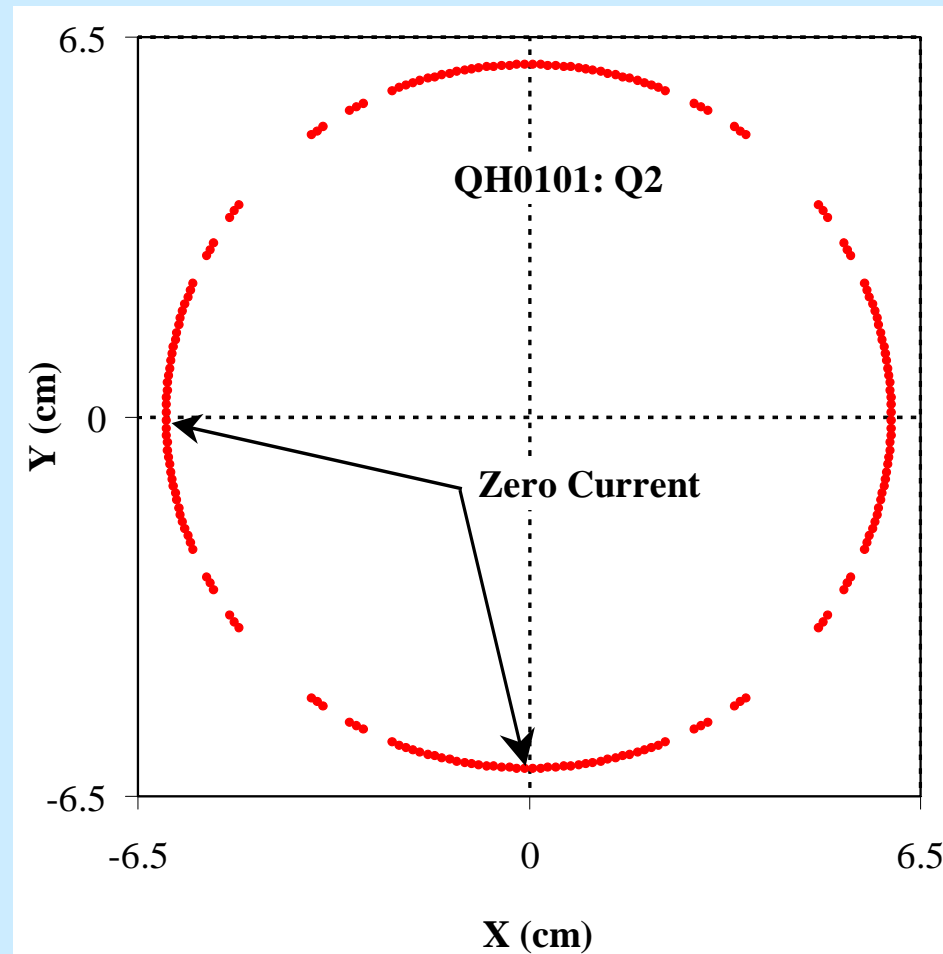
Modeling Field Quality with a Short

- Most likely area: splice from one sub-coil to the next.
- Would bypass current from the outermost turn.

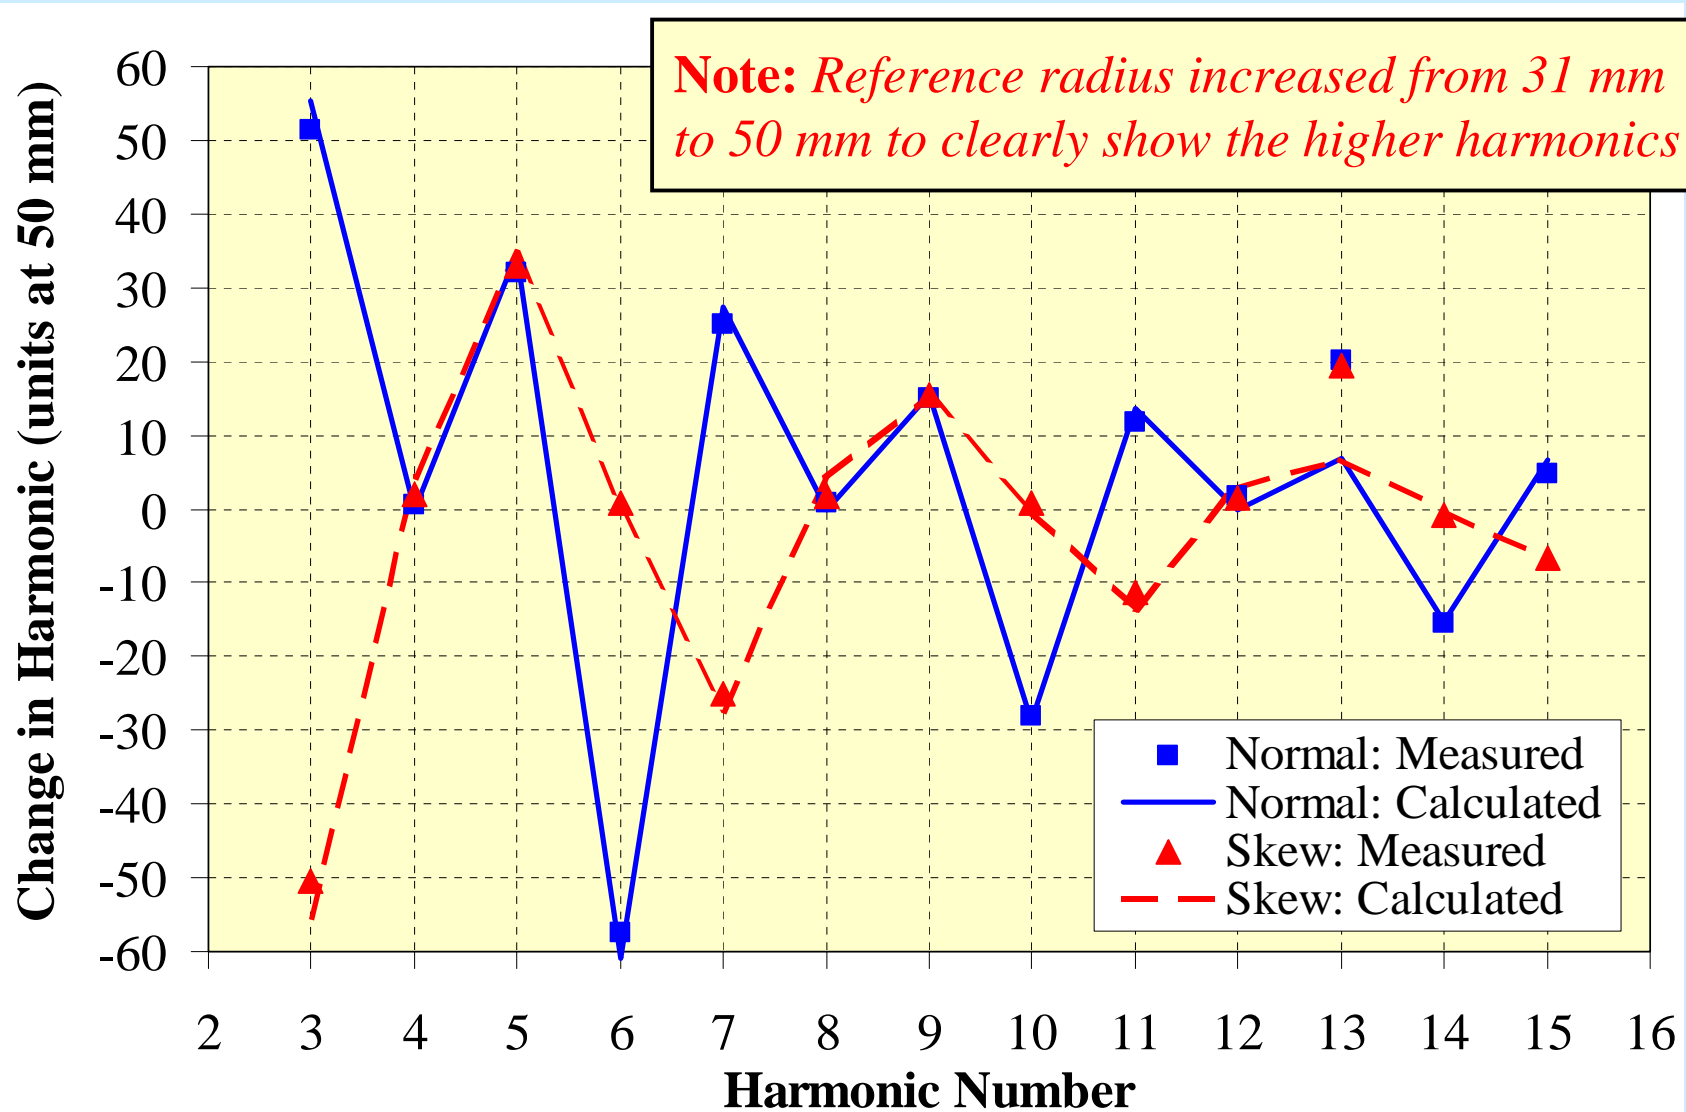
Computed Vs Measured Changes

- The excellent agreement between the calculated and the measured harmonics confirmed the presence of an electrical short at the midplane splice in the 3rd quadrant (between the 3rd and the 4th sub-coils).
- Since no further layers were yet wound on the magnet, the repair was relatively simple.
- Measurements after the repair confirmed that the harmonics returned to their original values.
- Later on in the production, two sub-coils were wound in a continuous pattern (spiral out, followed by spiral in), eliminating the need for a midplane splice.

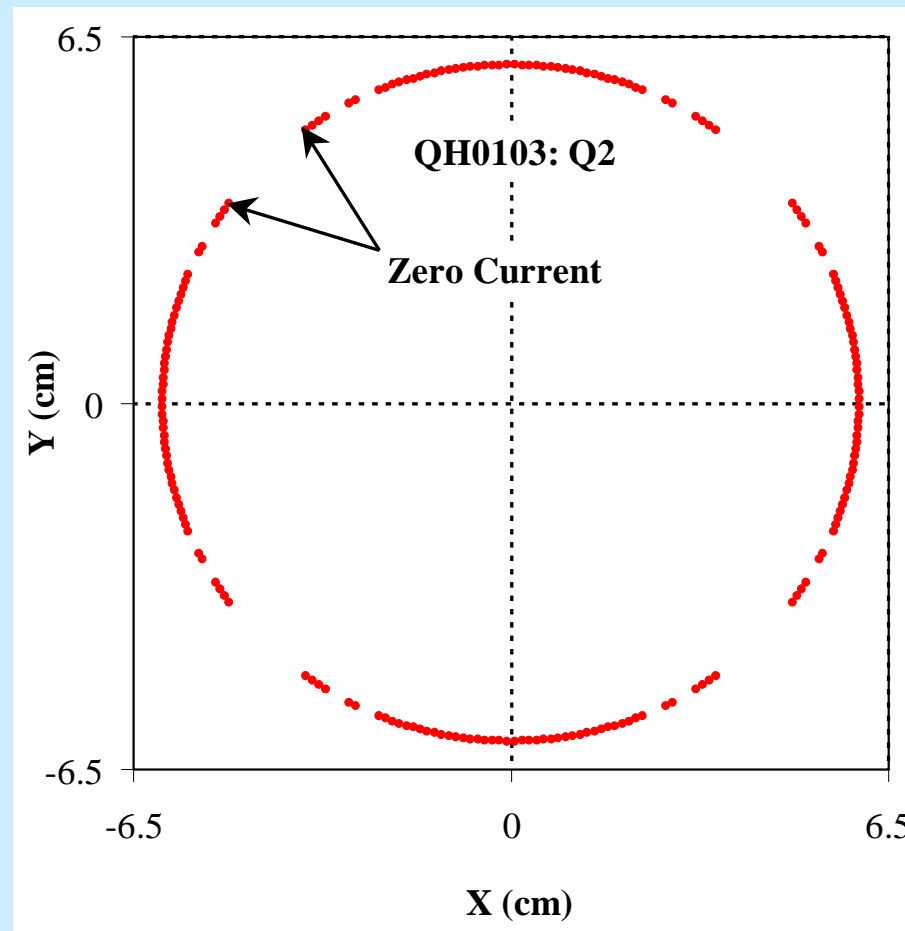
Modeling Field Errors in QH0103

- Most likely area: pole lead in the 2nd quadrant.
- Would bypass current from the pole-most turn.

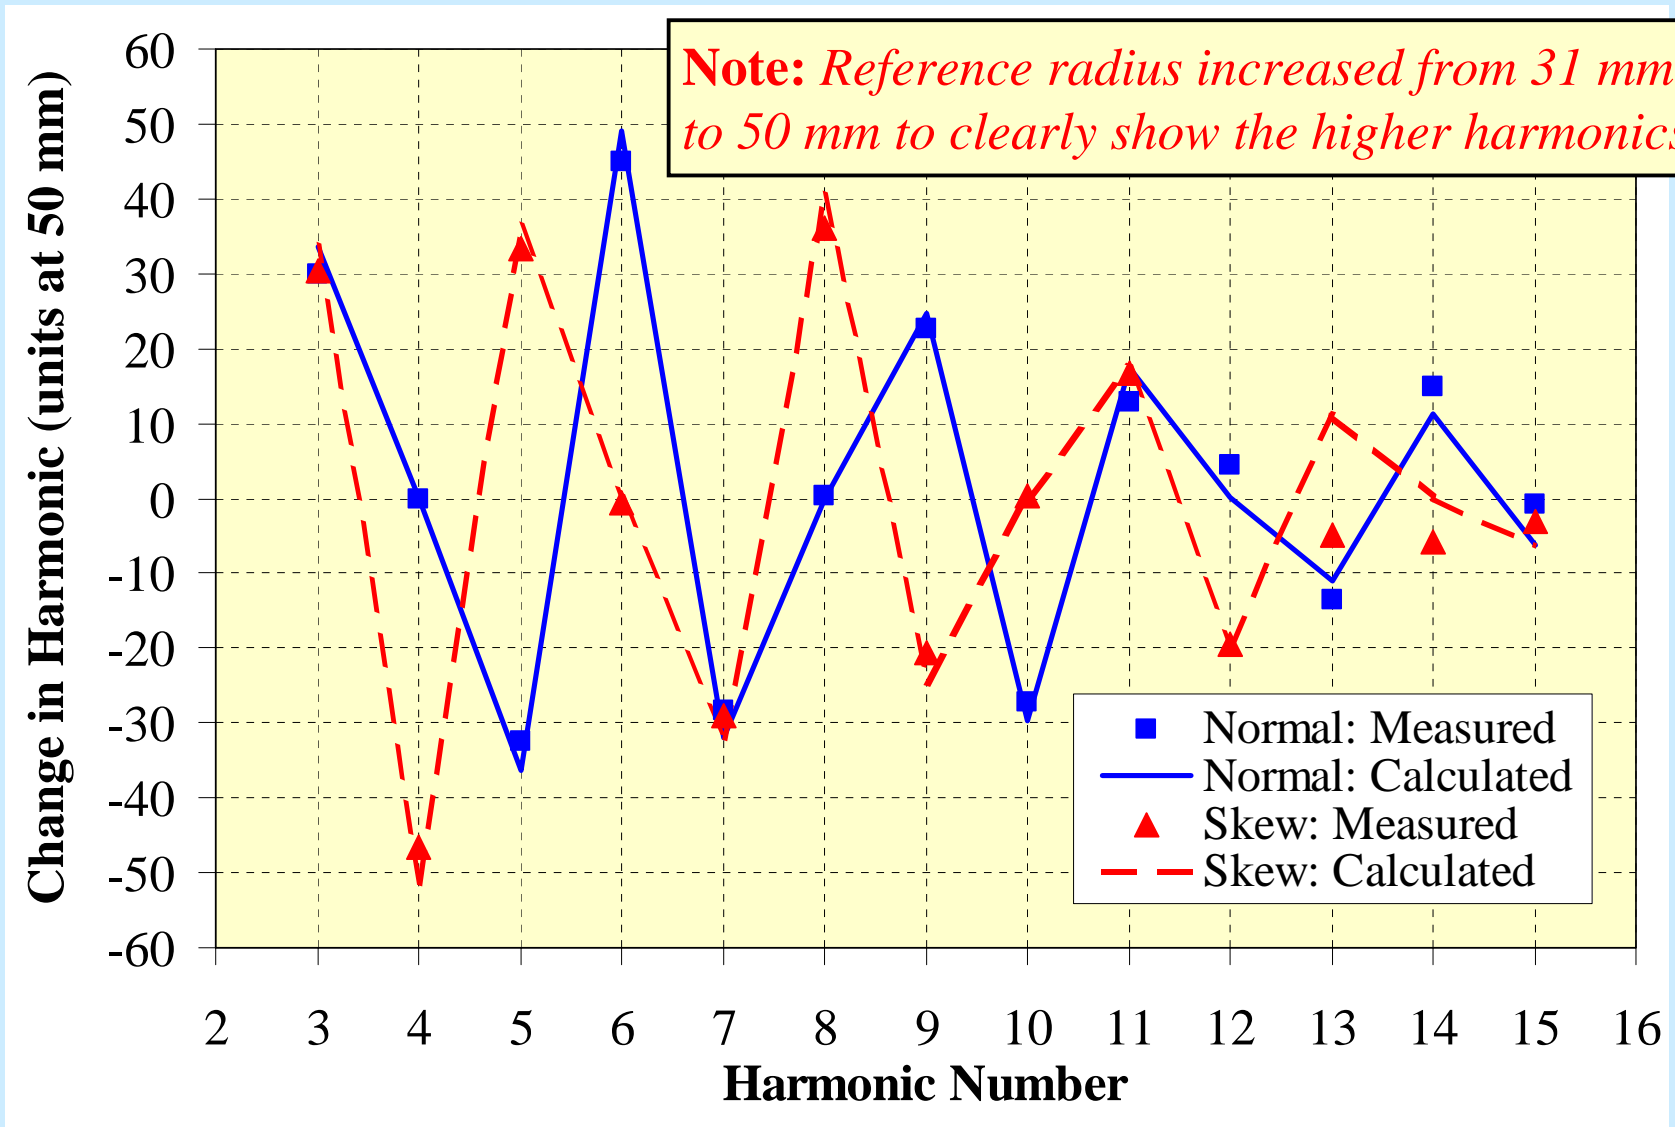
Computed Vs Measured Changes

- All three quadrupole layers were connected in series, making it difficult to measure individual layers.
- Warm measurements on individual layers were carried out at a very low current of 0.25A utilizing the voltage taps between the layers as current leads.
- These measurements revealed practically no changes in the first and the third quadrupole layer, but showed large changes in harmonics of the second layer. These changes were about as large as were seen earlier in the case of QH0101.
- The low current warm measurements thus clearly established a problem with the second quadrupole layer.
- Interestingly, there did not appear to be much loss of transfer function in the Q2 layer. This suggested that the problem was more likely to be in the pole region, than in the midplane region.
