Use of Warm Magnetic Measurements in Locating Electrical Shorts in Magnets

Animesh Jain, John Escallier and Peter Wanderer

Superconducting Magnet Division
Brookhaven National Laboratory
Upton, New York 11973-5000, USA

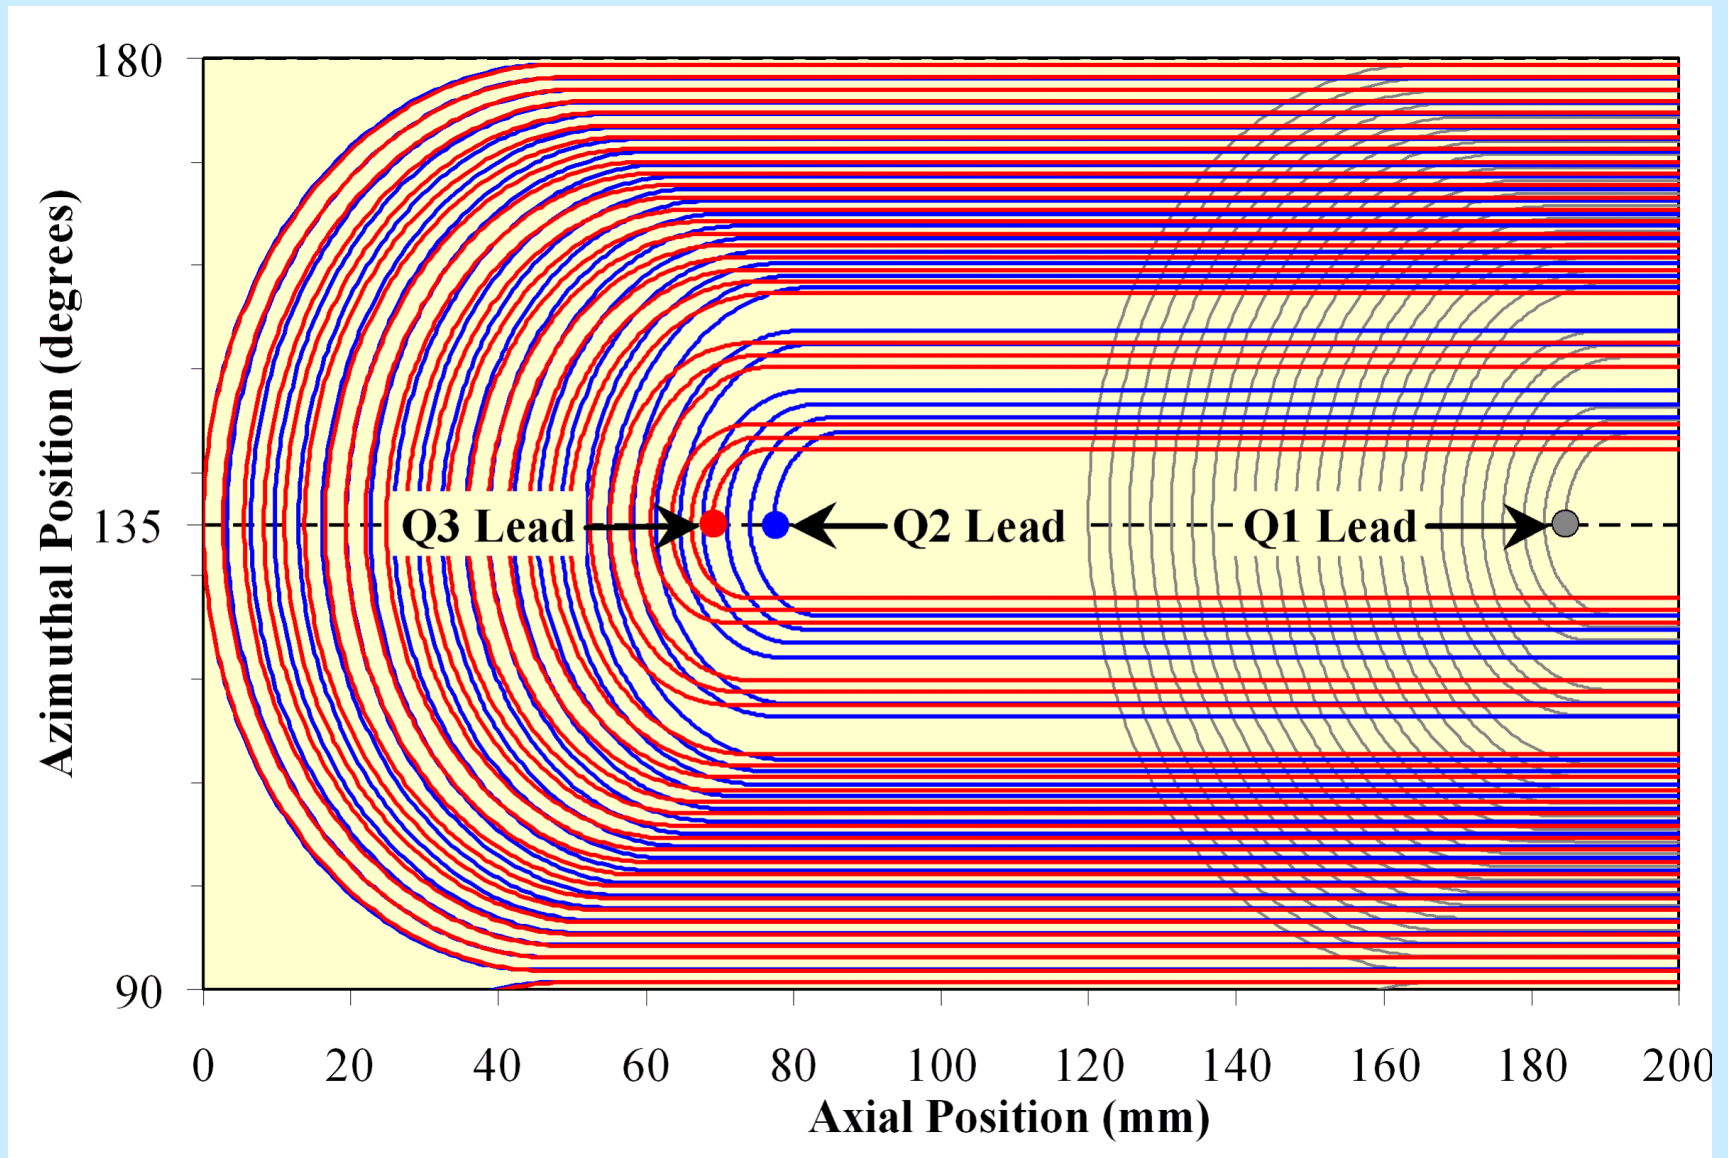
QH0103: Q1, Q2, Q3 Layers

- Large changes in the harmonics were also observed in the main quadrupole of the magnet QH0103 after all the layers were completed. These changes did not appear as dramatic as were shown before, since the three quadrupole layers were only measured in series, but were still much larger than usual.
- At this stage in production, magnetic measurements were not carried out after each step. So, it was difficult to judge at what step the problem could have occurred.
- There could have been a problem with any of the three main quadrupole layers, which were now buried under one skew dipole/skew quadrupole layer and one sextupole layer. The layers outside the quadrupole alone represented ~ 3 months of work.

- All three quadrupole layers were connected in series, making it difficult to measure individual layers.
- Warm measurements on individual layers were carried out at a very low current of 0.25A utilizing the voltage taps between the layers as current leads.
- These measurements revealed practically no changes in the first and the third quadrupole layer, but showed large changes in harmonics of the second layer. These changes were about as large as were seen earlier in the case of QH0101.
- The low current warm measurements thus clearly established a problem with the second quadrupole layer.
- Interestingly, there did not appear to be much loss of transfer function in the Q2 layer. This suggested that the problem was more likely to be in the pole region, than in the midplane region.

Fortunately, it was possible to carefully cut into the S-glass wrap to reach the pole lead of Q2, without affecting other layers. Thus, a repair could be performed without sacrificing any layer.
